Manual 154
Revision 4
October 2013

Propeller Owner's Manual & Log Book

Series HC-A6()-3()()

Six-Blade Lightweight Turbine Propeller

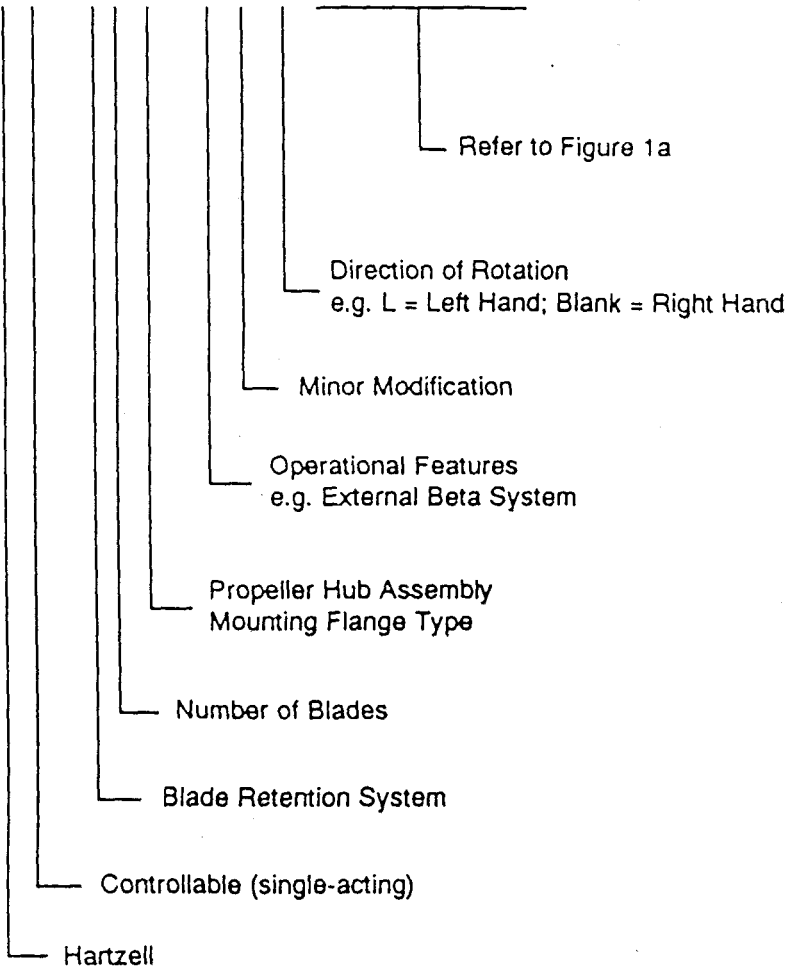
Model Designation System
Figure 1

Typical Single-Acting, Six Blade Lightweight Turbine Propeller

HC - A6() - 3()()/Blade Model

NOTE: Parentheses in the model designation system can indicate either that an option or modification is included in the hub assembly or that it is not included in the hub assembly.
